Fatigue Degradation in Compressively Loaded Composite Laminates

R.L. RAMKUMAR

NORTHROP CORPORATION
HAWTHORNE, CA 90250

CONTRACT NAS1-15956
APRIL 1981

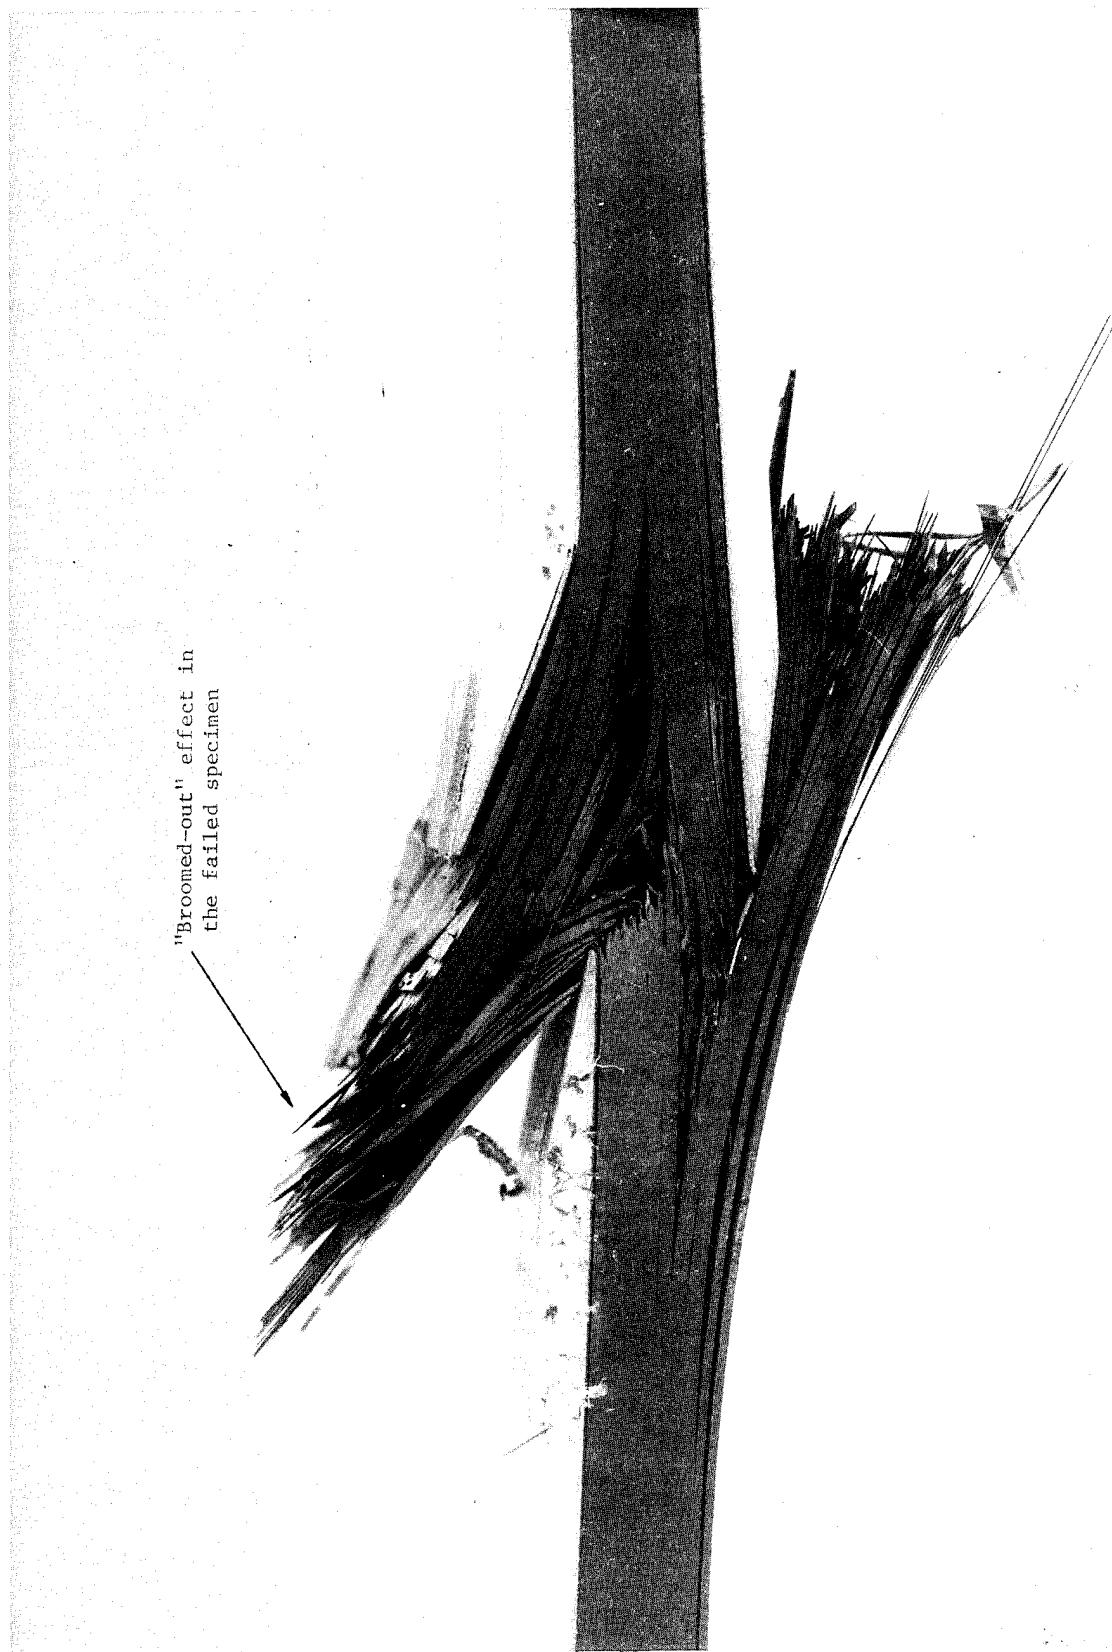
Figure 62. Photograph of a Laminate A Specimen (4284-60) after Residual Strength Testing; Test Series 10
